## PROVISION OF POTABLE WATER AND EARLY WARNING FOR FLOODING AND POLLUTION IN MAKOKO EEGUN COMMUNITY OF LAGOS, NIGERIA

**Name:** Stephanie Nzeke Waniko<sup>1,2</sup>, Samuel Olatunde Popoola<sup>1</sup> Ibironke Olubamise<sup>3</sup>, Rose Agbo<sup>3</sup>, John Paul Unyimadu<sup>2</sup>, Nubi Olubunmi<sup>1</sup>, Rod Shelle<sup>1</sup>, Ismail Adejare Ladigbolu<sup>1</sup>, Olakunle Lateef Olaniran<sup>1</sup>, Oluwaseun Adedayo Adeleye<sup>1</sup>, Falilu Adekunbi<sup>1</sup>, and, David omaghom<sup>2</sup>

**Affiliation :** <sup>1</sup>Nigerian Institute for Oceanography and Marine Research, <sup>2</sup>Eco Restoration Foundation of Nigeria

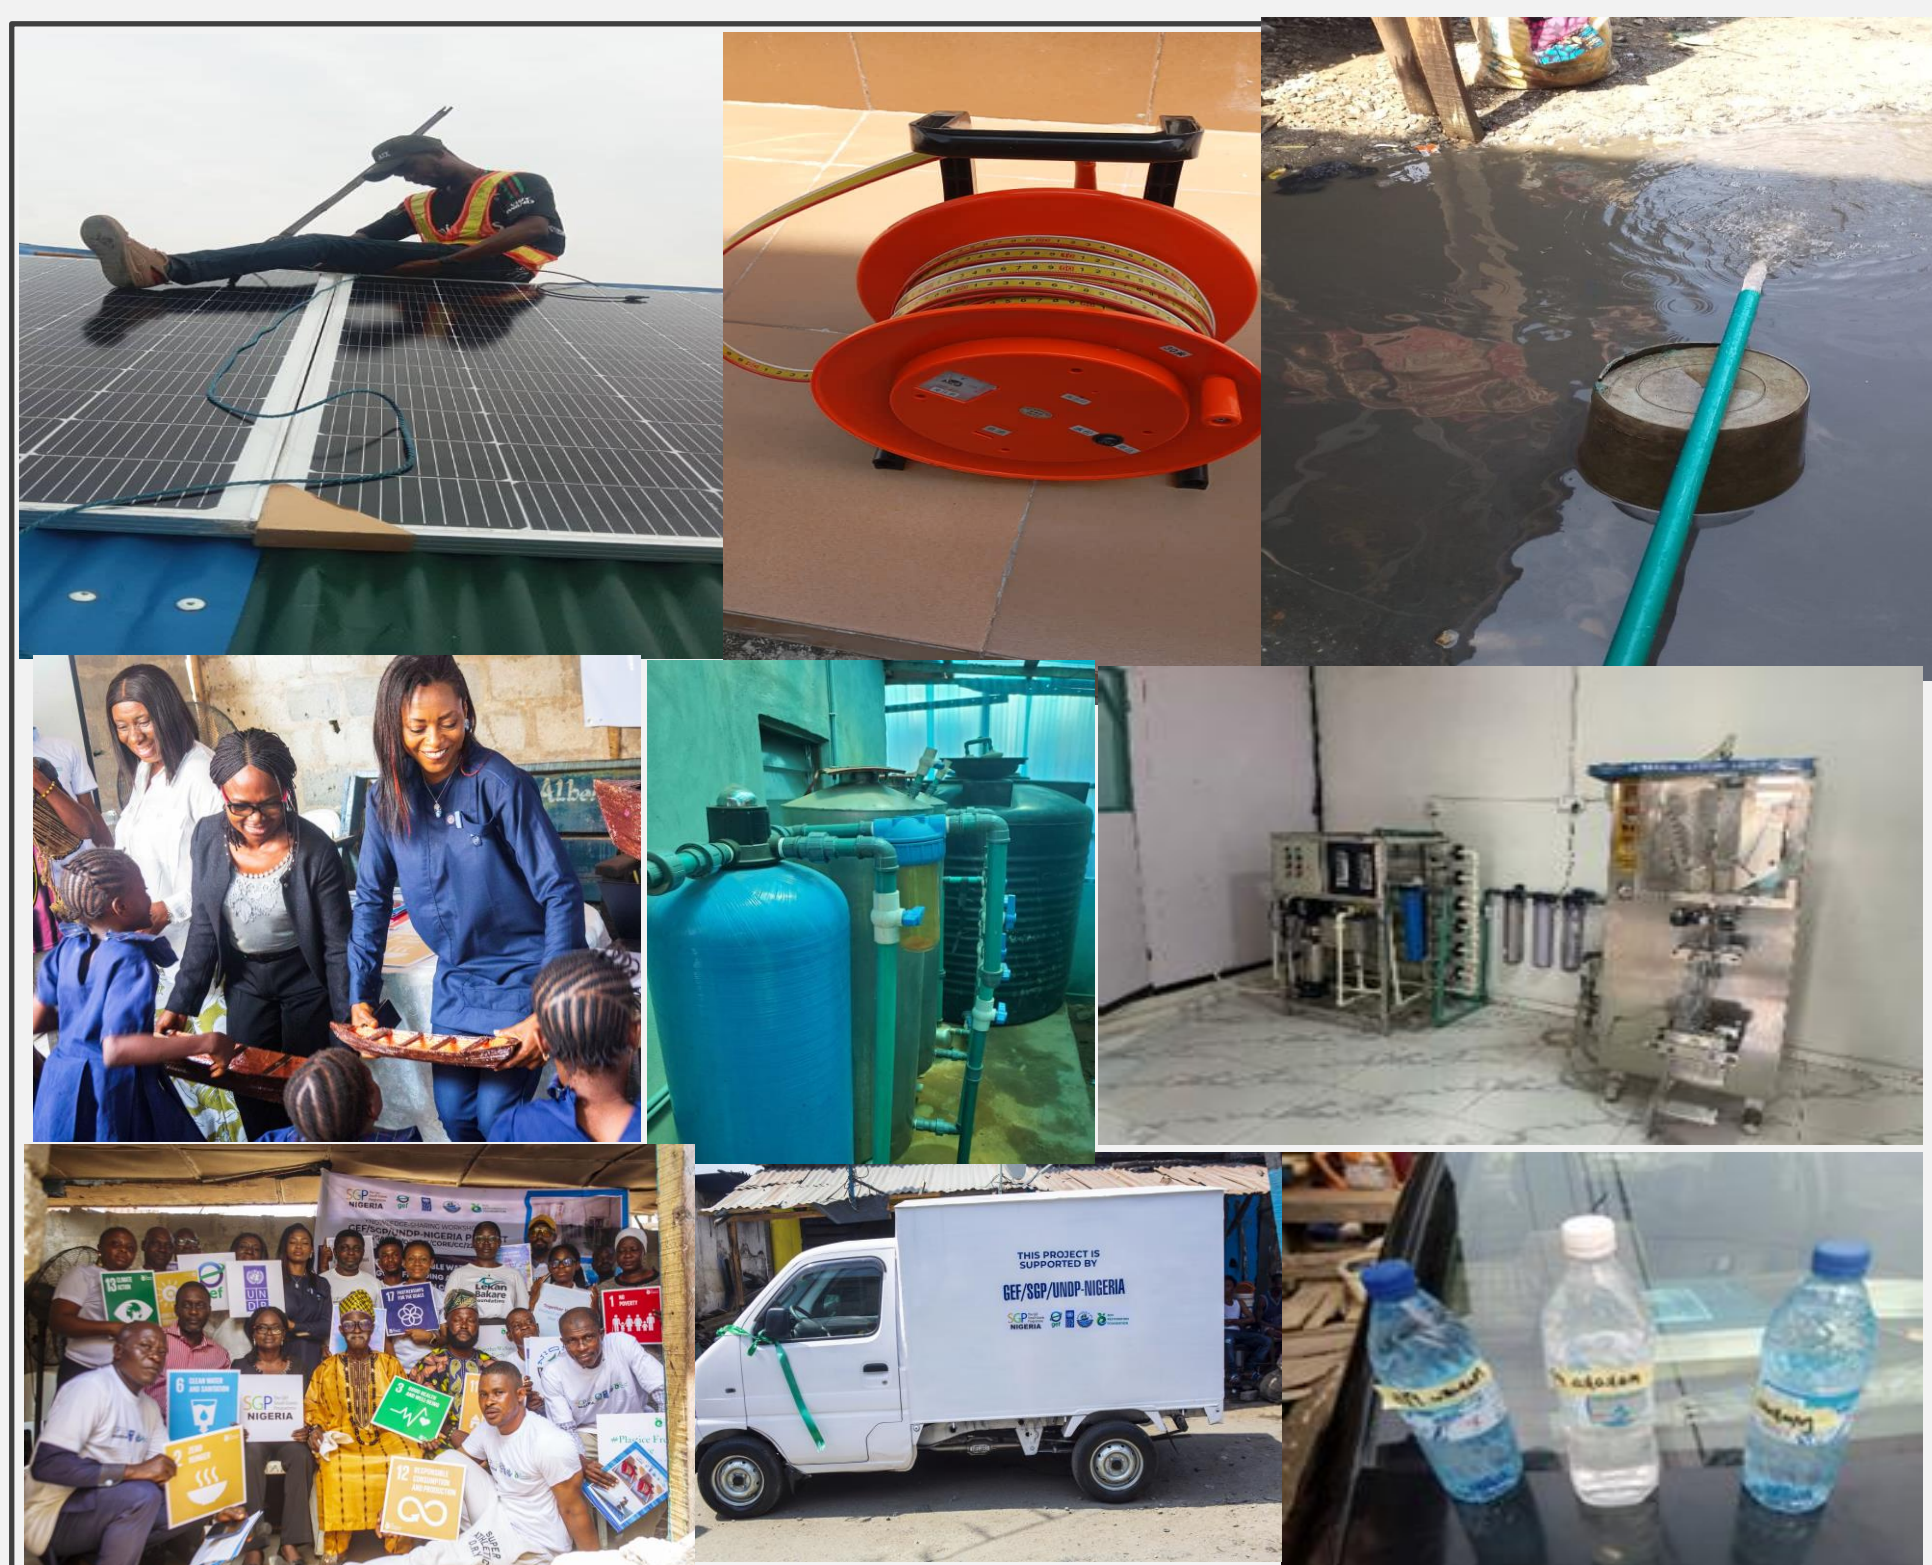
**Fig. 1: Provision of potable borehole, Water level indicator, and alert beeper for flooding monitoring, sensitisation , water treatment plant to the community with renewable energy**

The installation of a comprehensive water treatment plant with Reverse Osmosis system (1,500 LPH). Flood Resilience in the community through youth training on early flood warnings using automatic water level cables. Improvement in Public Health through Awareness workshops leading to better hygiene and reduced pollution and introduction of circular economy practices especially for plastic waste.
